## Chapter 9

# FIRE BEHAVIOR IN WORLD TRADE CENTER 2

### 9.1 INTRODUCTION

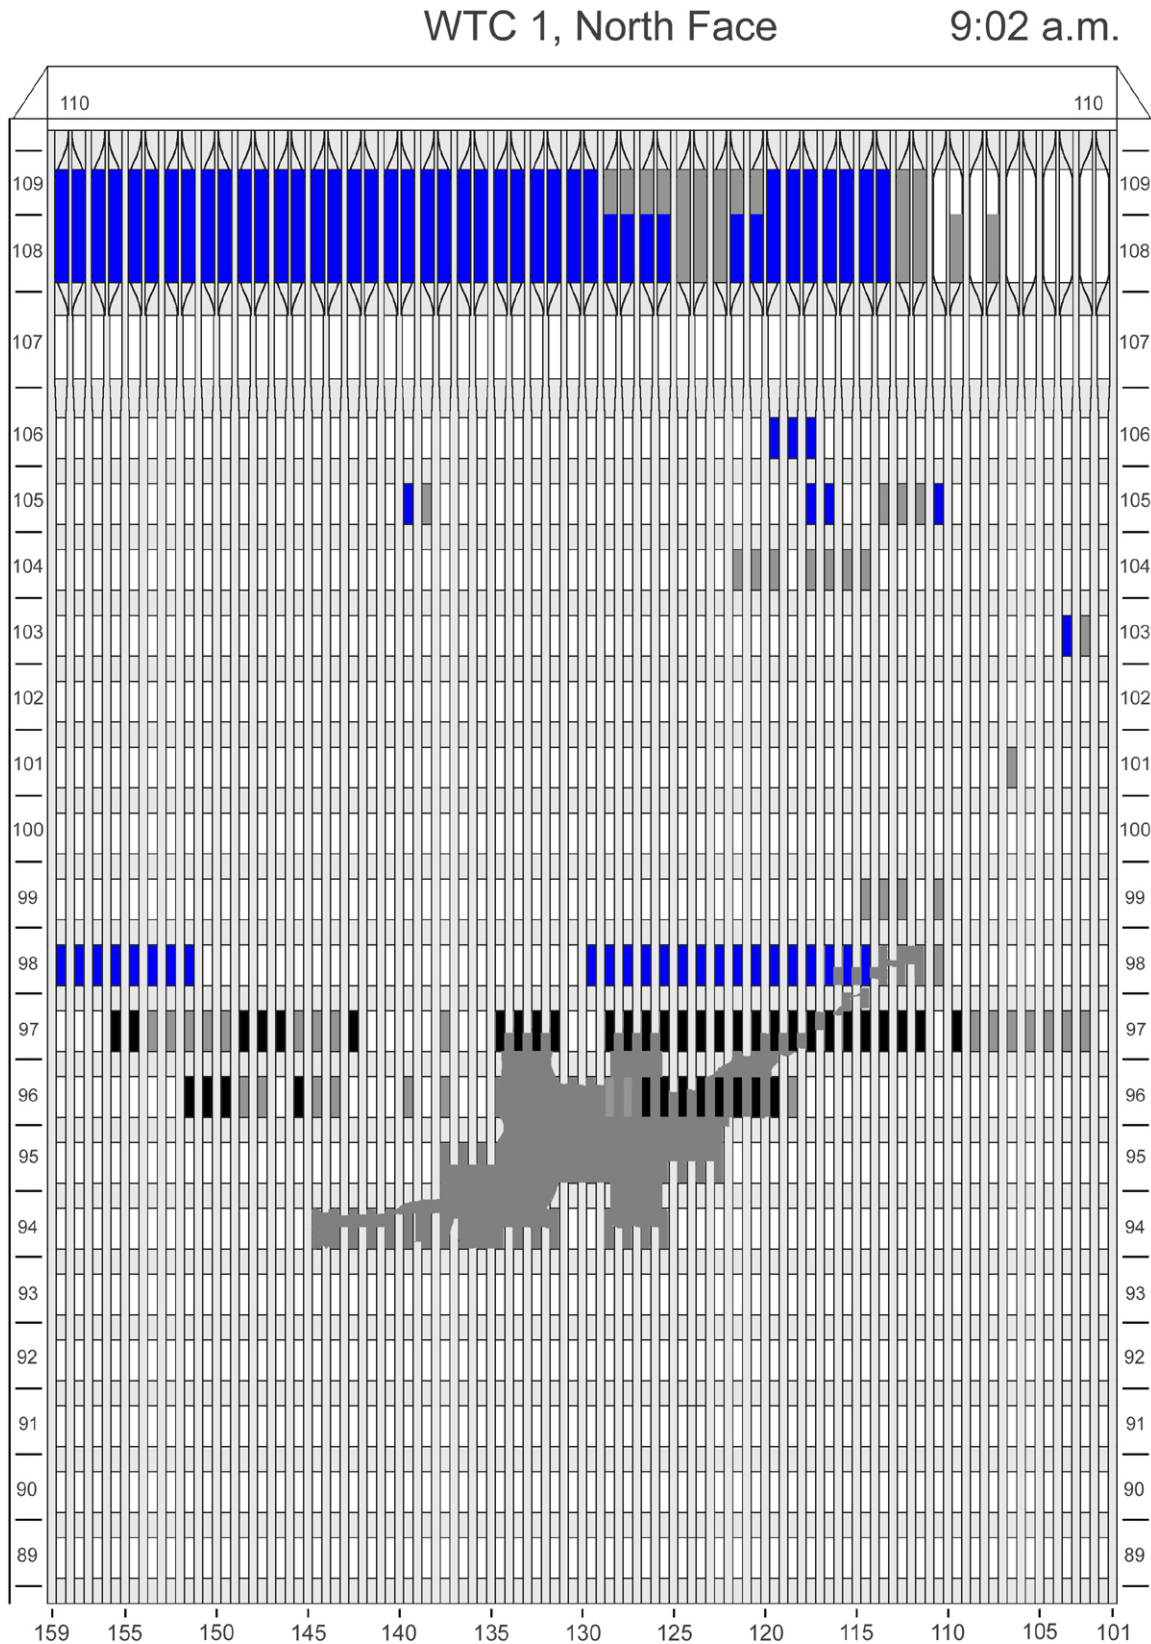
**Figure C-18. Diagram of the north face of WTC 1 for floors 89 to 110 at 9:02 a.m. showing windows where smoke was observed and those that were hidden from view.**

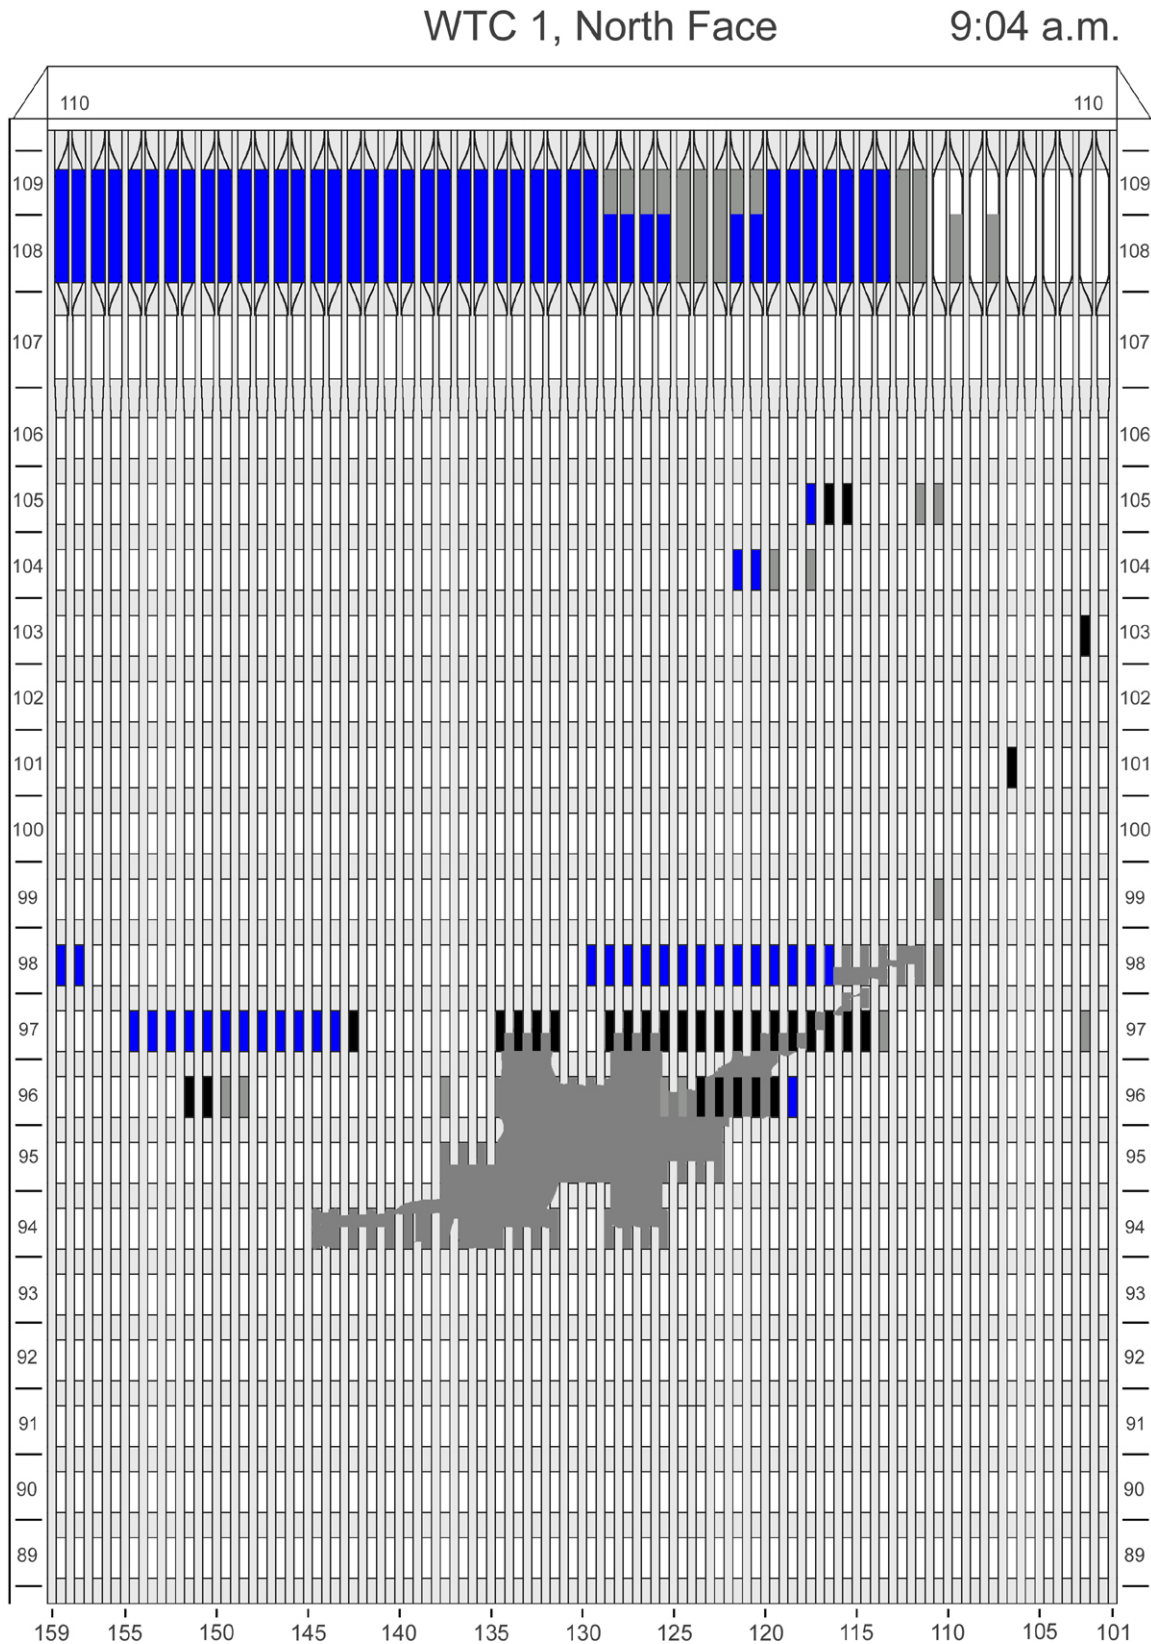
**Figure C-20. Diagram of the north face of WTC 1 for floors 89 to 110 at 9:04 a.m. showing windows where smoke was observed and those that were hidden from view.**

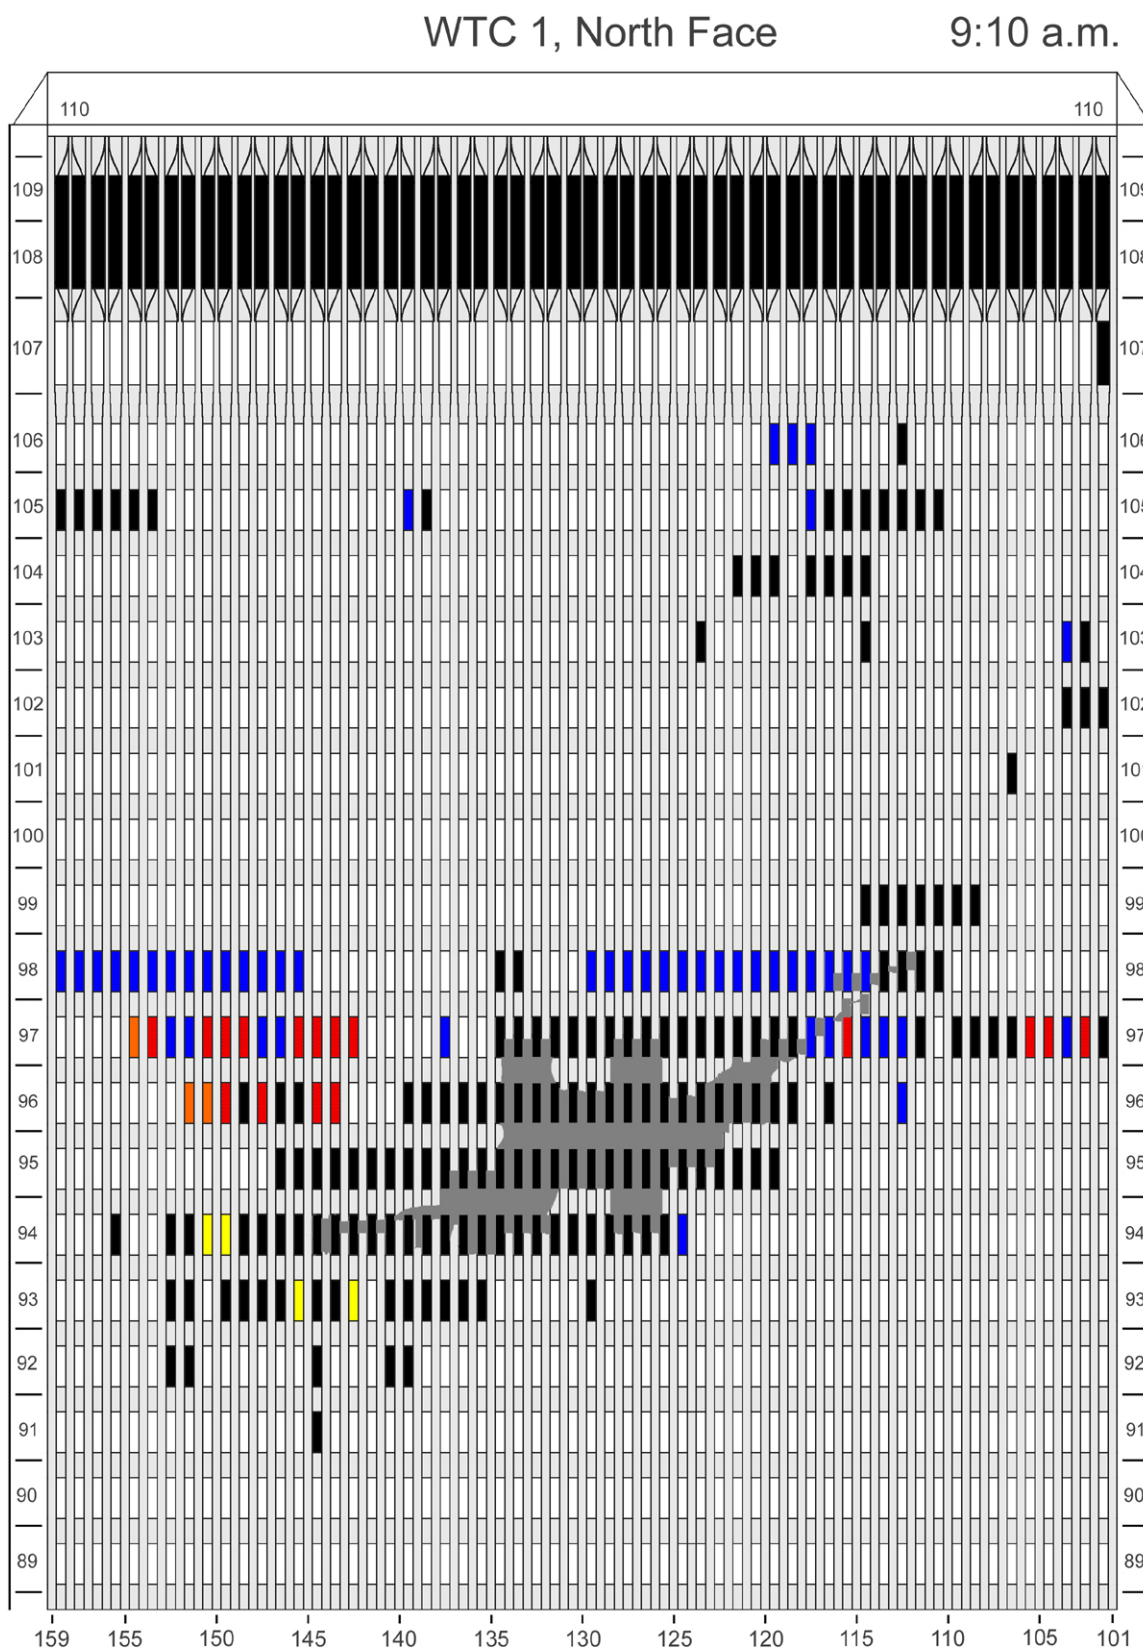
**Figure C-21. Diagram of the north face of WTC 1 for floors 89 to 110 at 9:10 a.m. showing the condition of windows and locations of fires.**

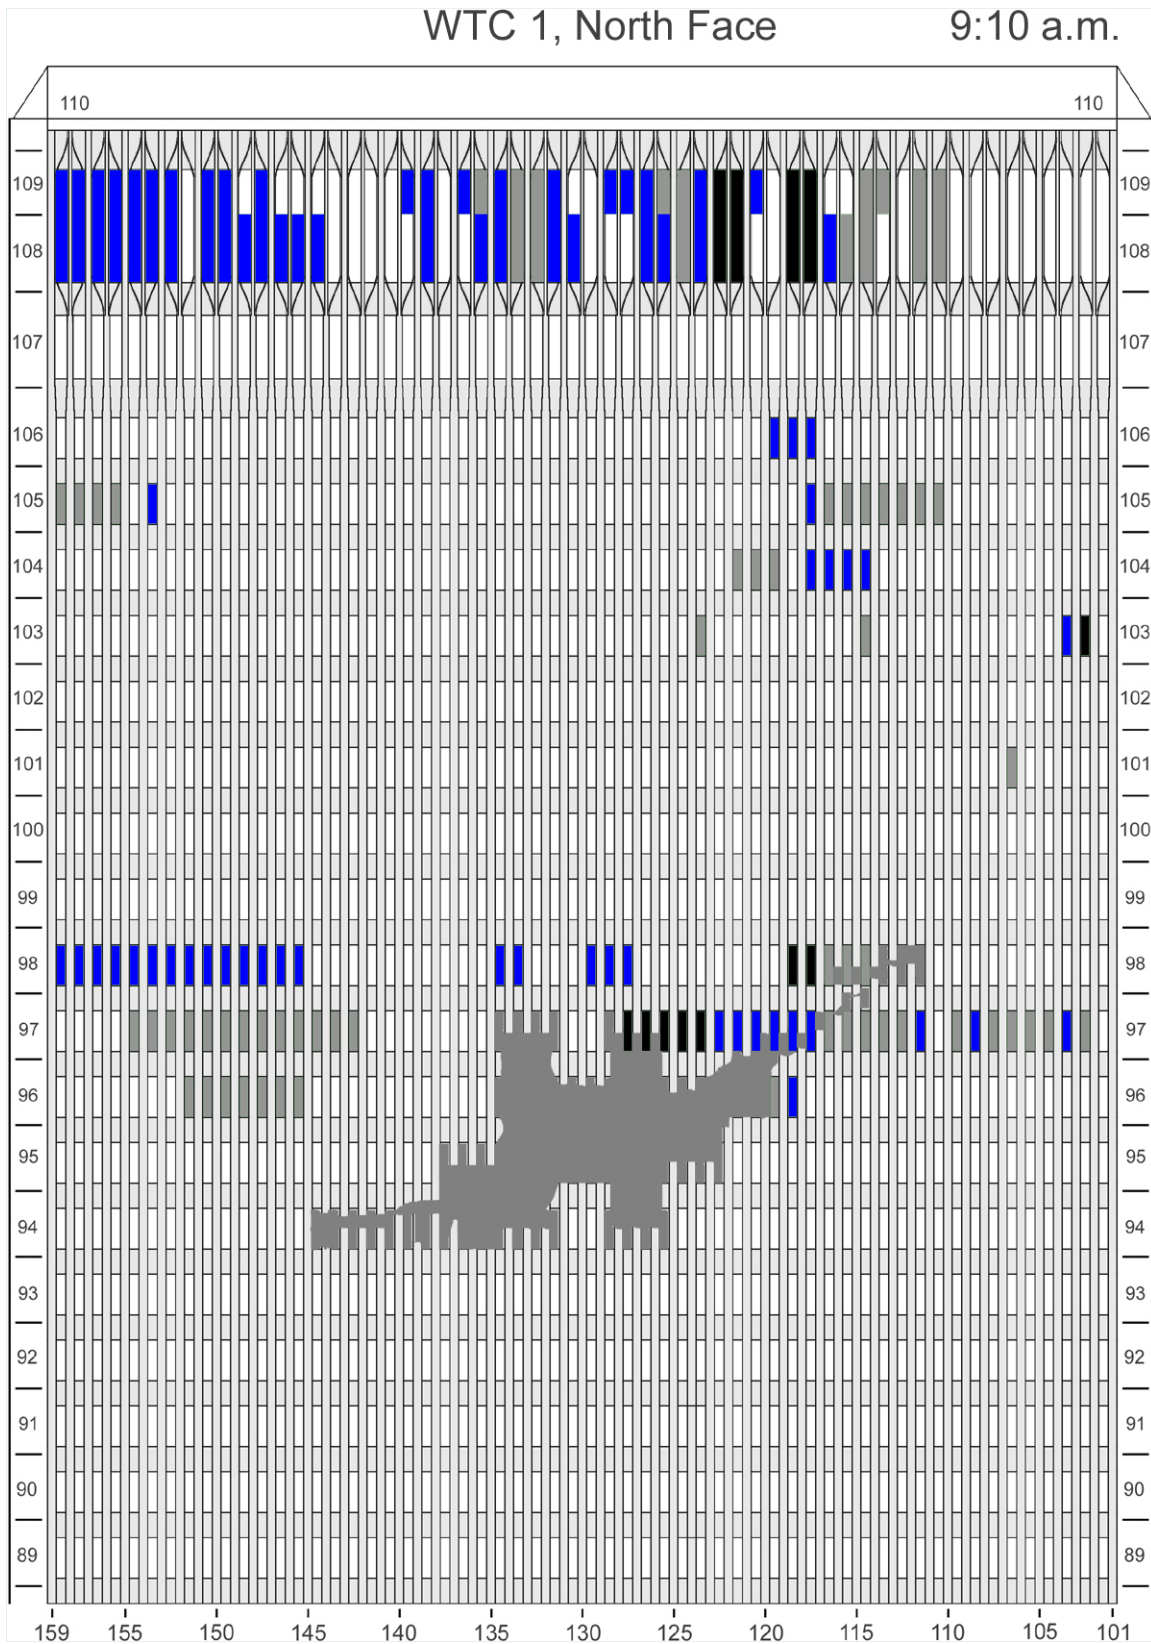
**Figure C-22. Diagram of the north face of WTC 1 for floors 89 to 110 at 9:10 a.m. showing windows where smoke was observed and those that were hidden from view.**

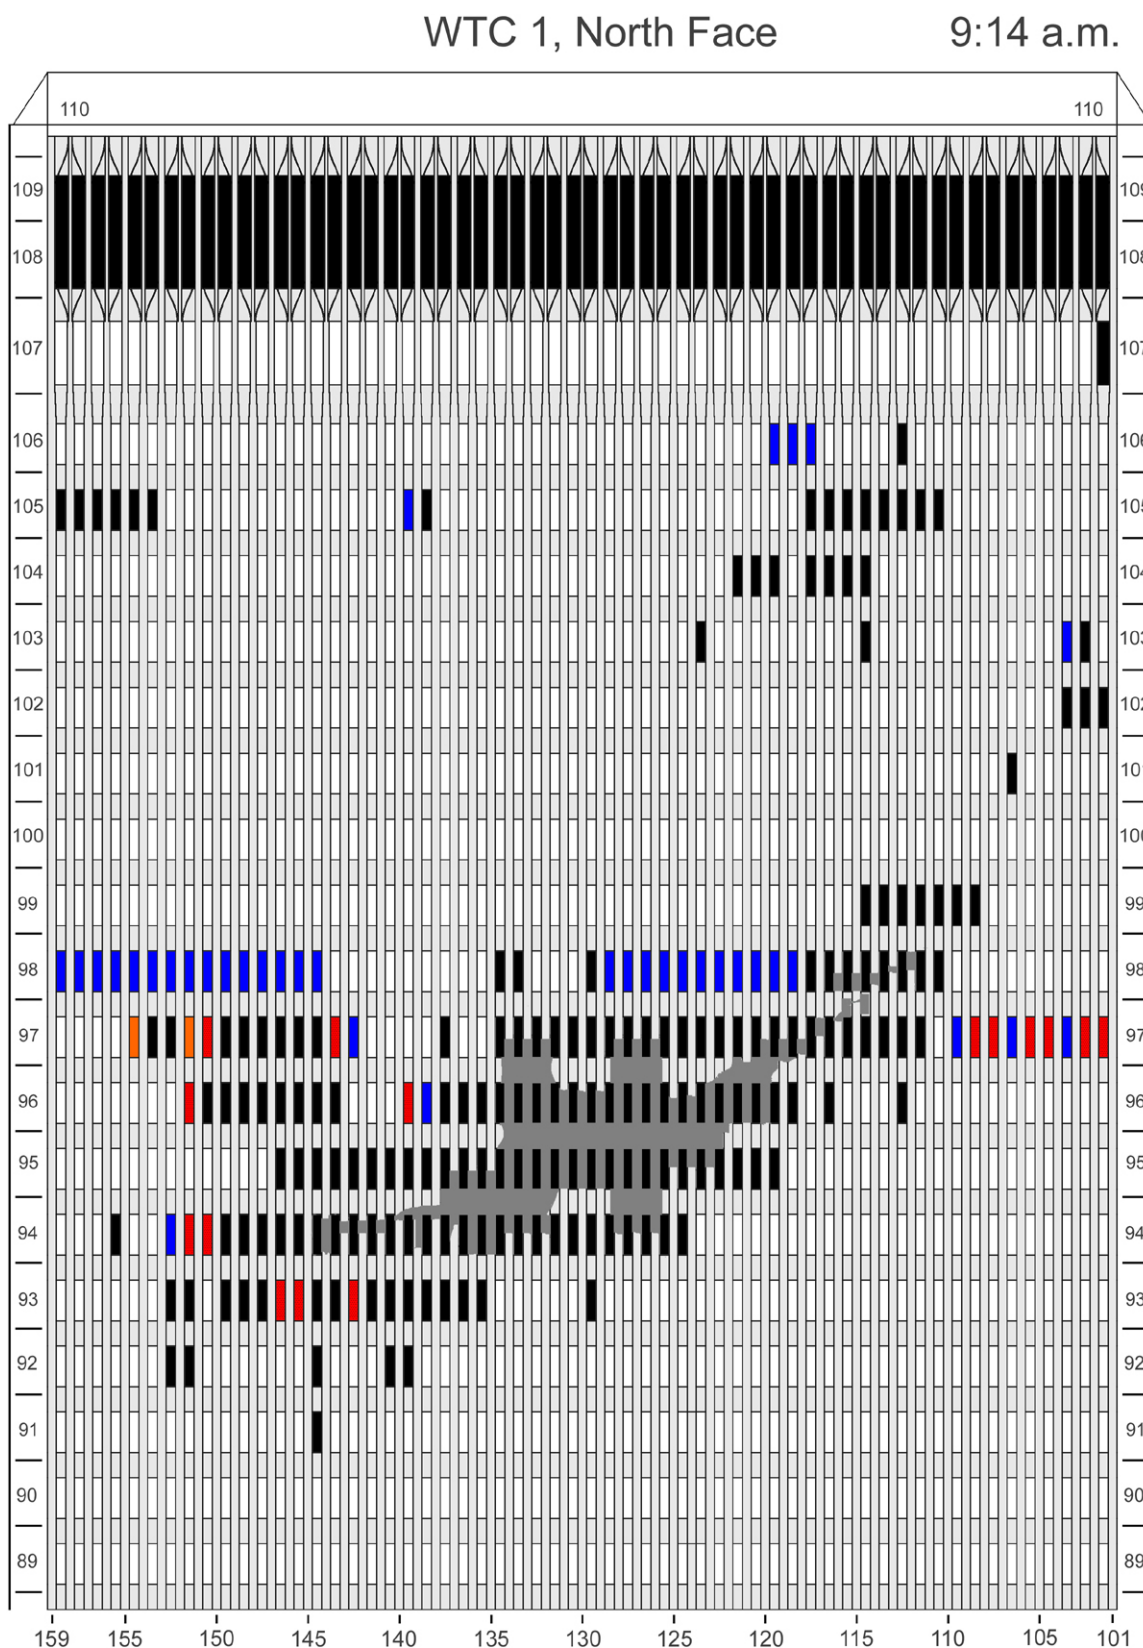
**Figure C-23. Diagram of the north face of WTC 1 for floors 89 to 110 at 9:14 a.m. showing the condition of windows and locations of fires.**

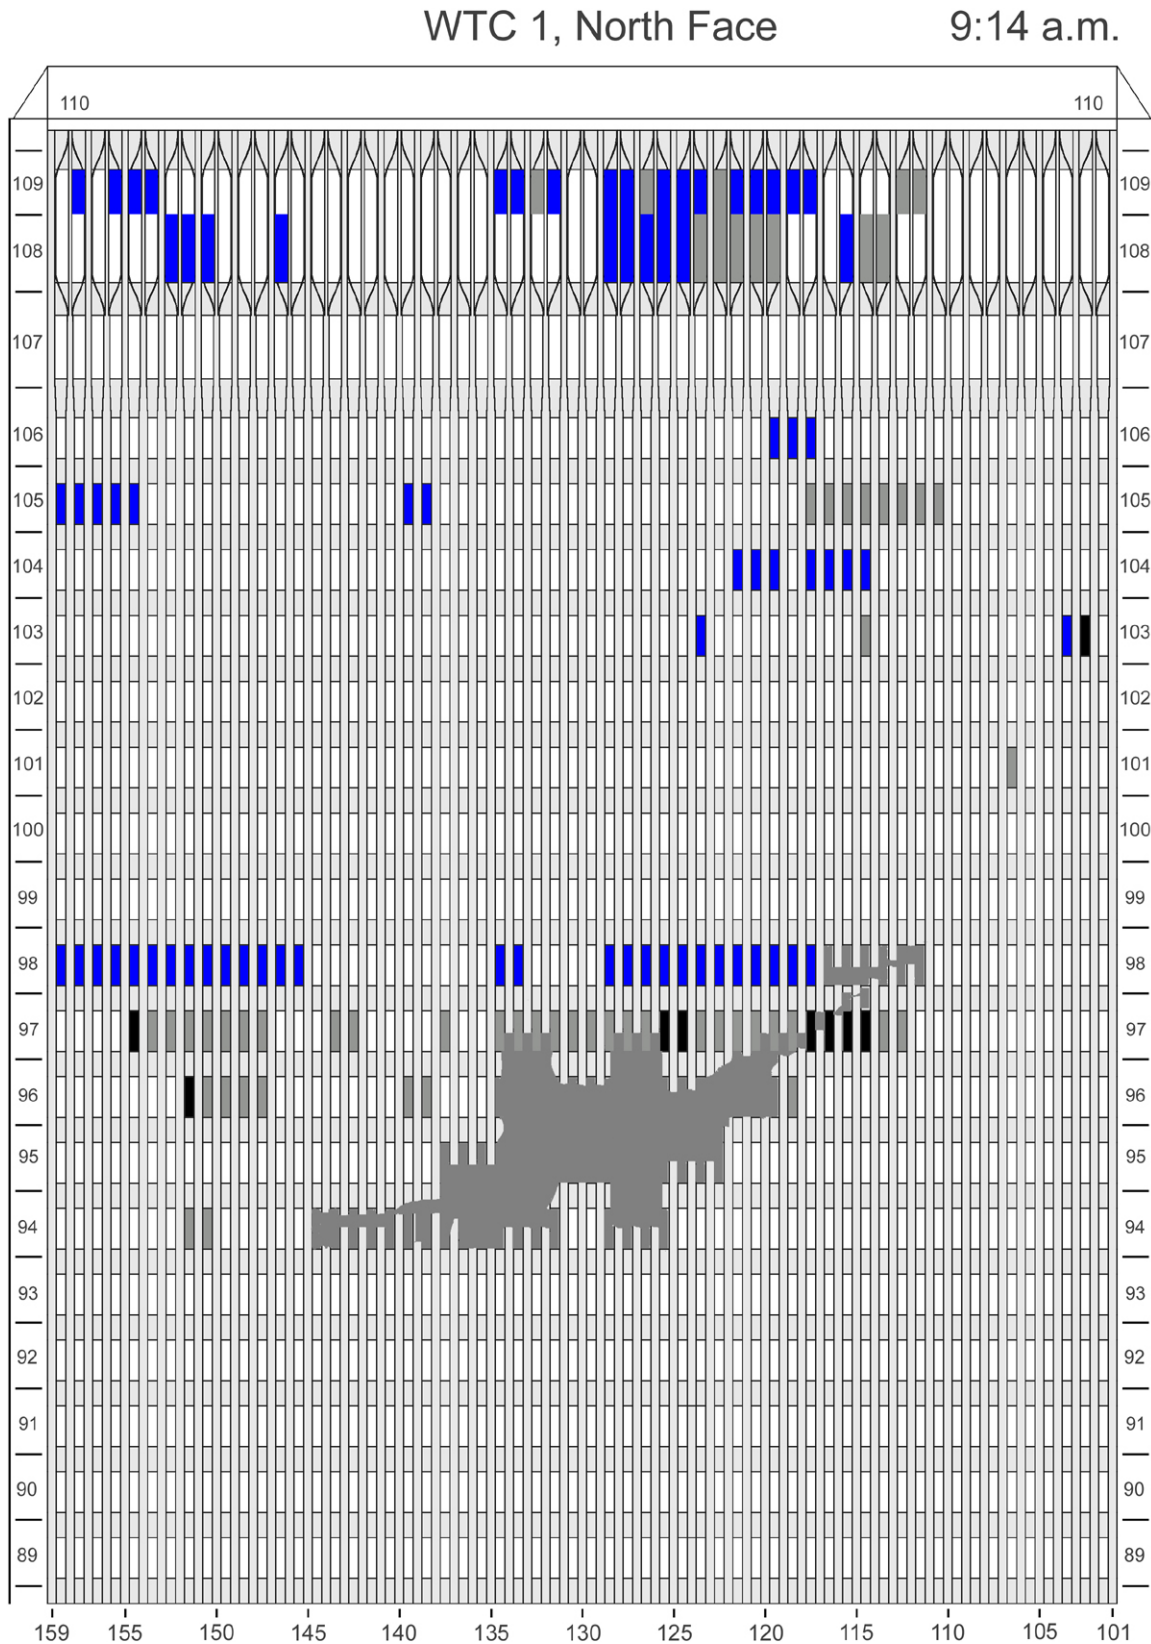
**Figure C-24. Diagram of the north face of WTC 1 for floors 89 to 110 at 9:14 a.m. showing windows where smoke was observed and those that were hidden from view.**

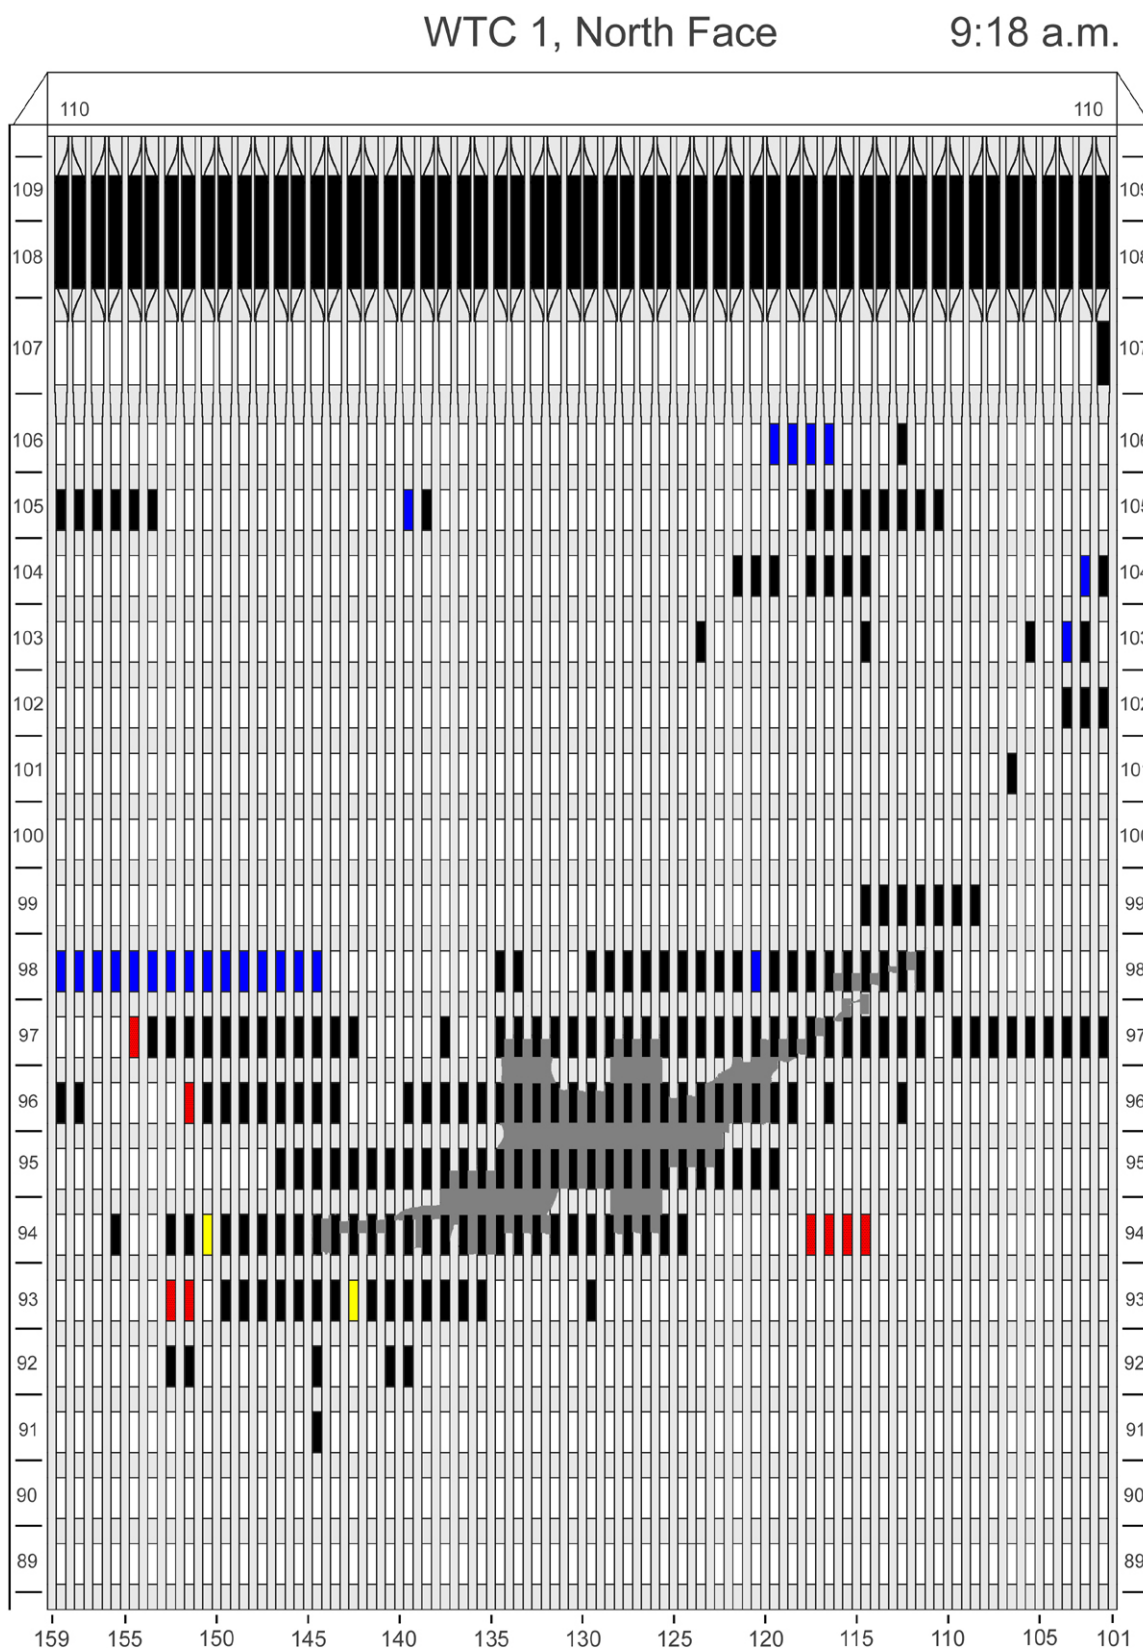
**Figure C-25. Diagram of the north face of WTC 1 for floors 89 to 110 at 9:18 a.m. showing the condition of windows and locations of fires.**

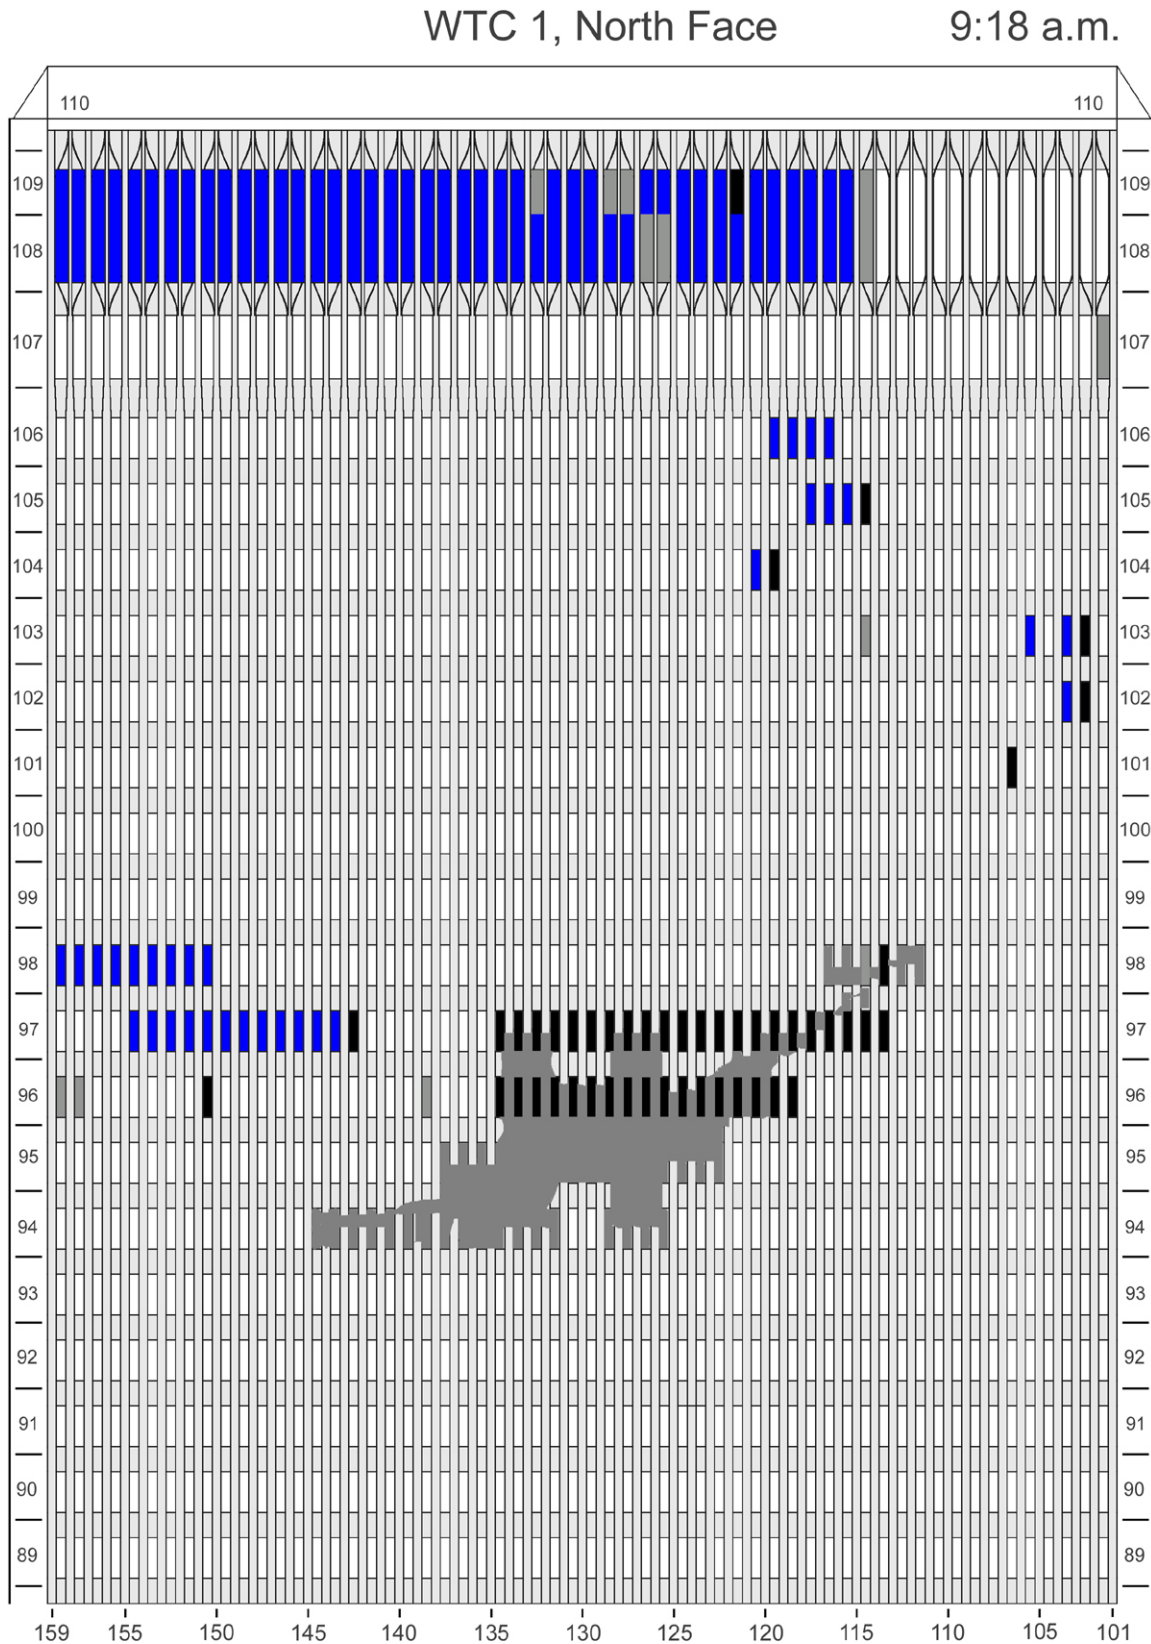
**Figure C-26. Diagram of the north face of WTC 1 for floors 89 to 110 at 9:18 a.m. showing windows where smoke was observed and those that were hidden from view.**

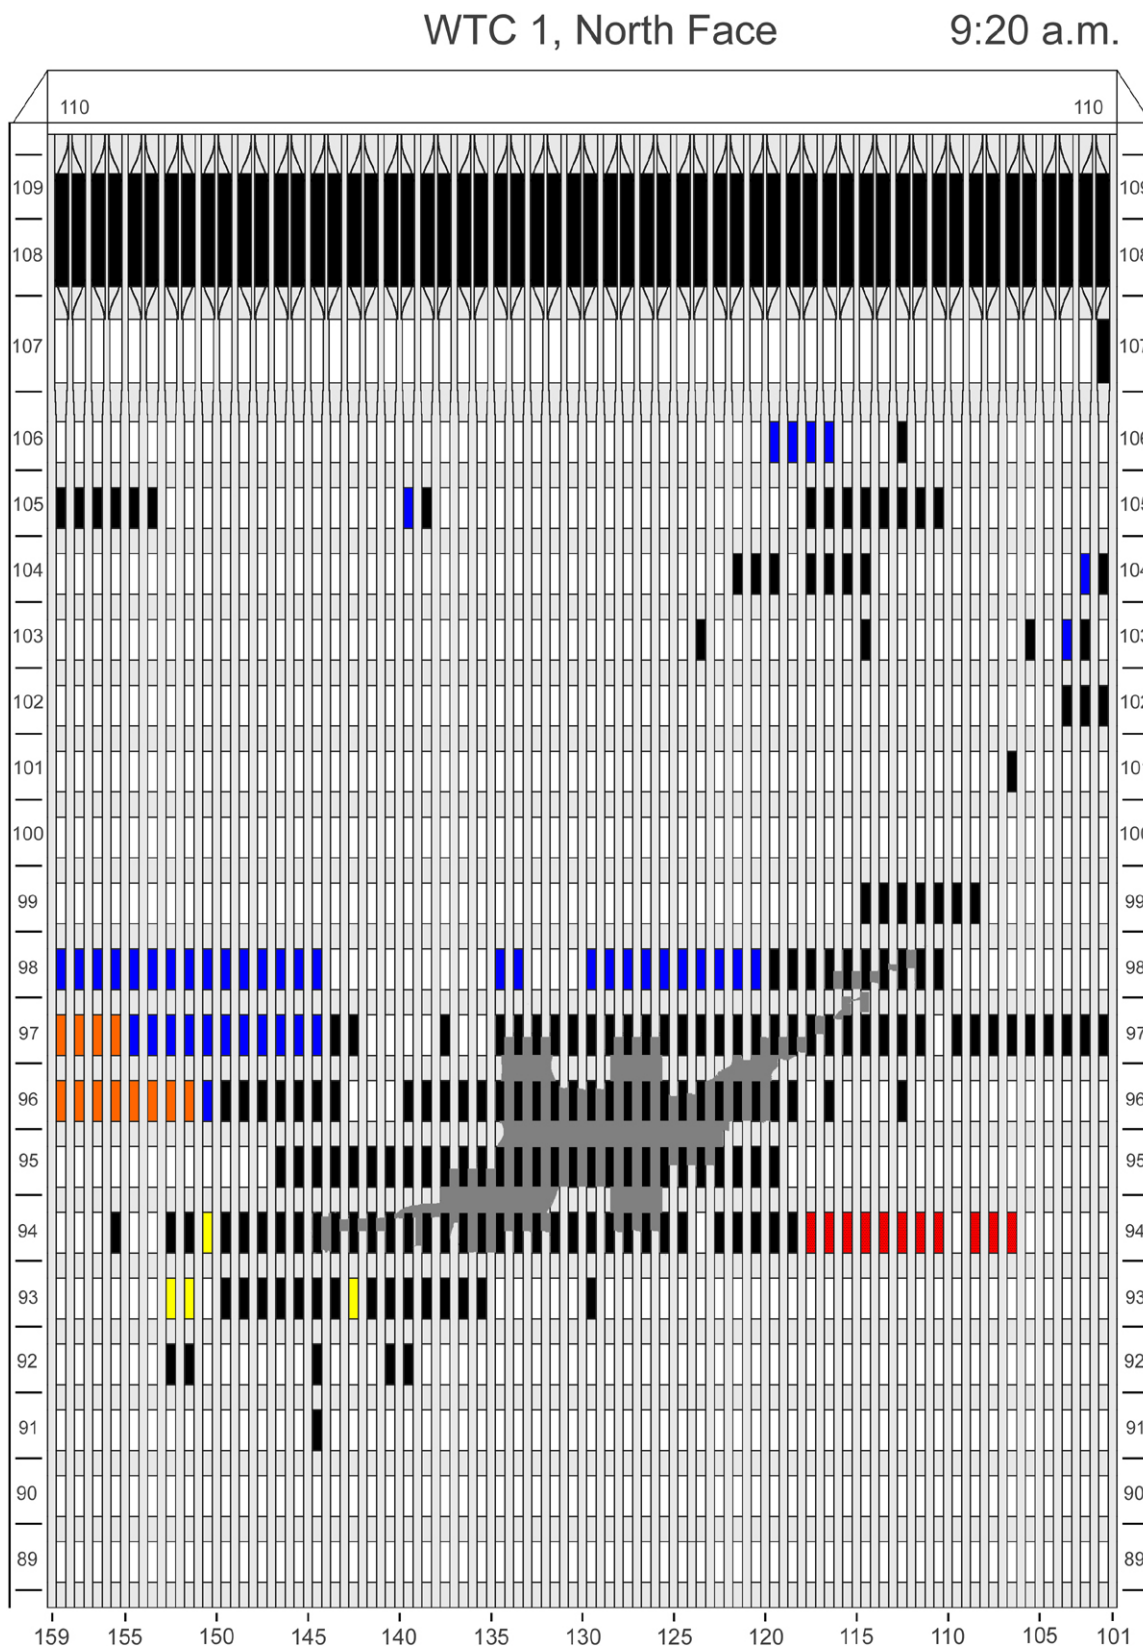
**Figure C-27. Diagram of the north face of WTC 1 for floors 89 to 110 at 9:20 a.m. showing the condition of windows and locations of fires.**

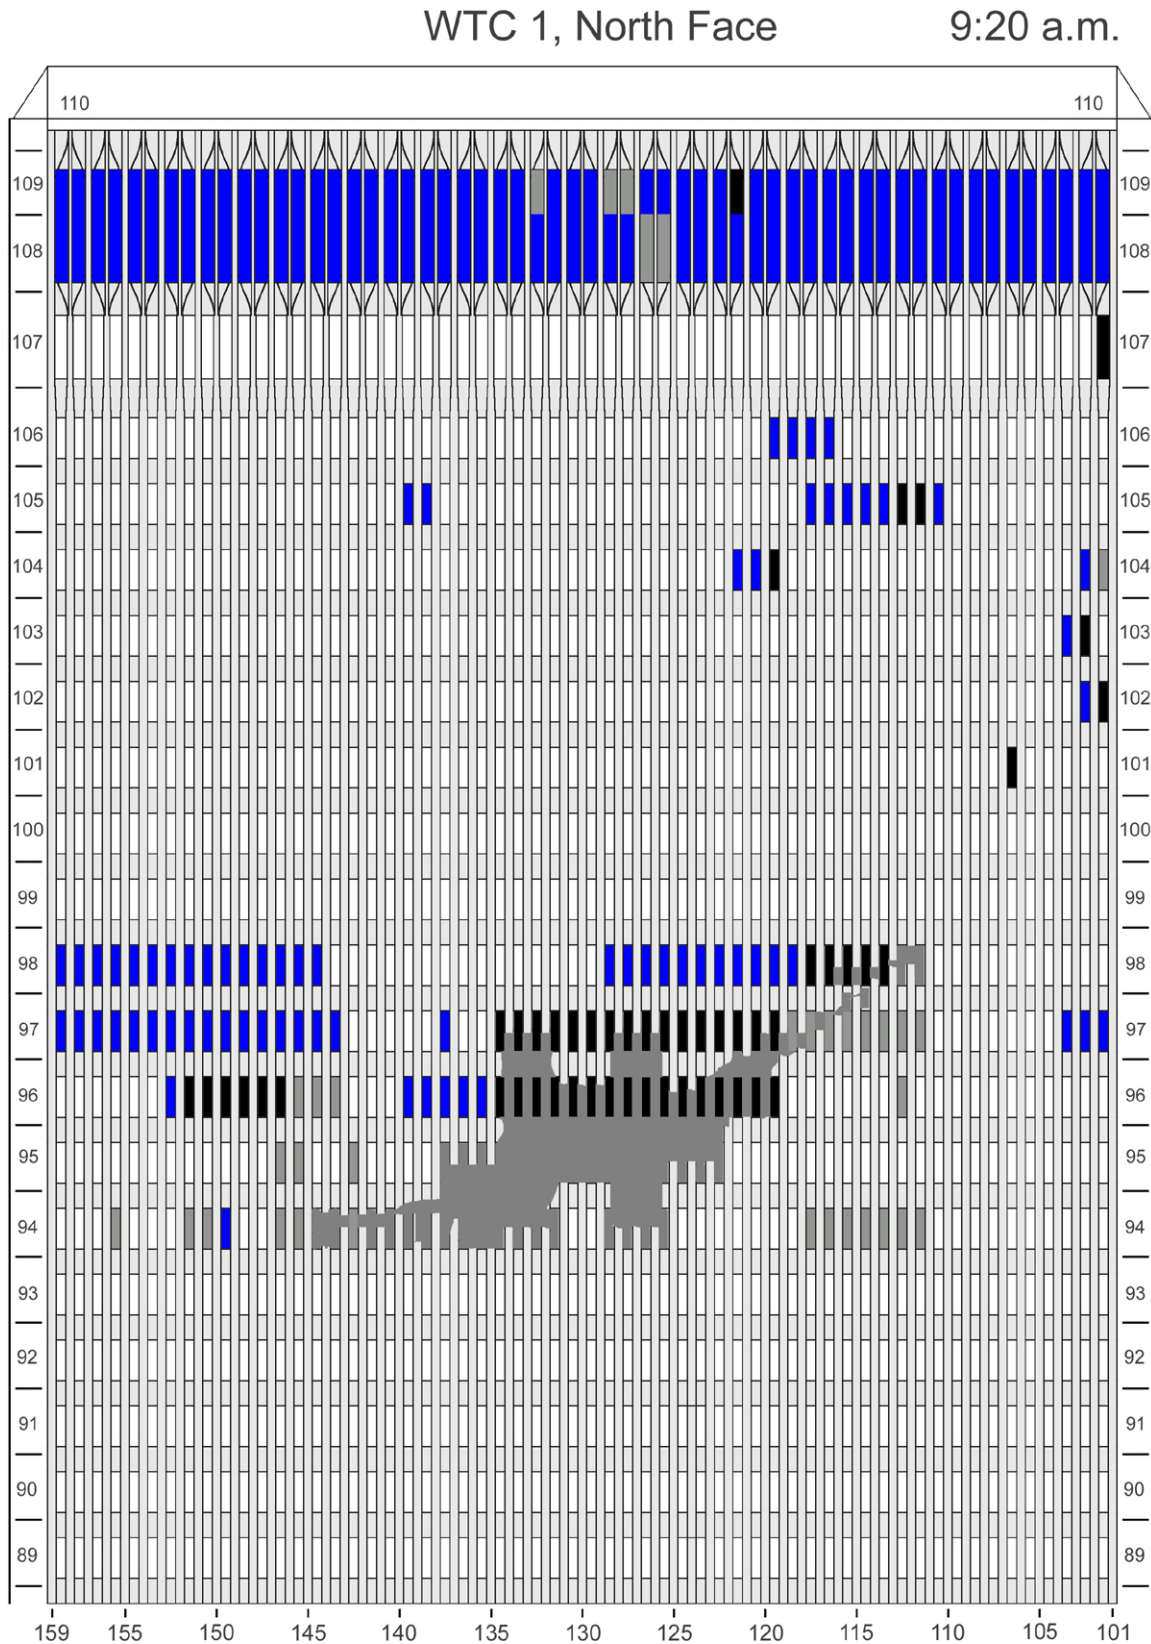
**Figure C-28. Diagram of the north face of WTC 1 for floors 89 to 110 at 9:20 a.m. showing windows where smoke was observed and those that were hidden from view.**

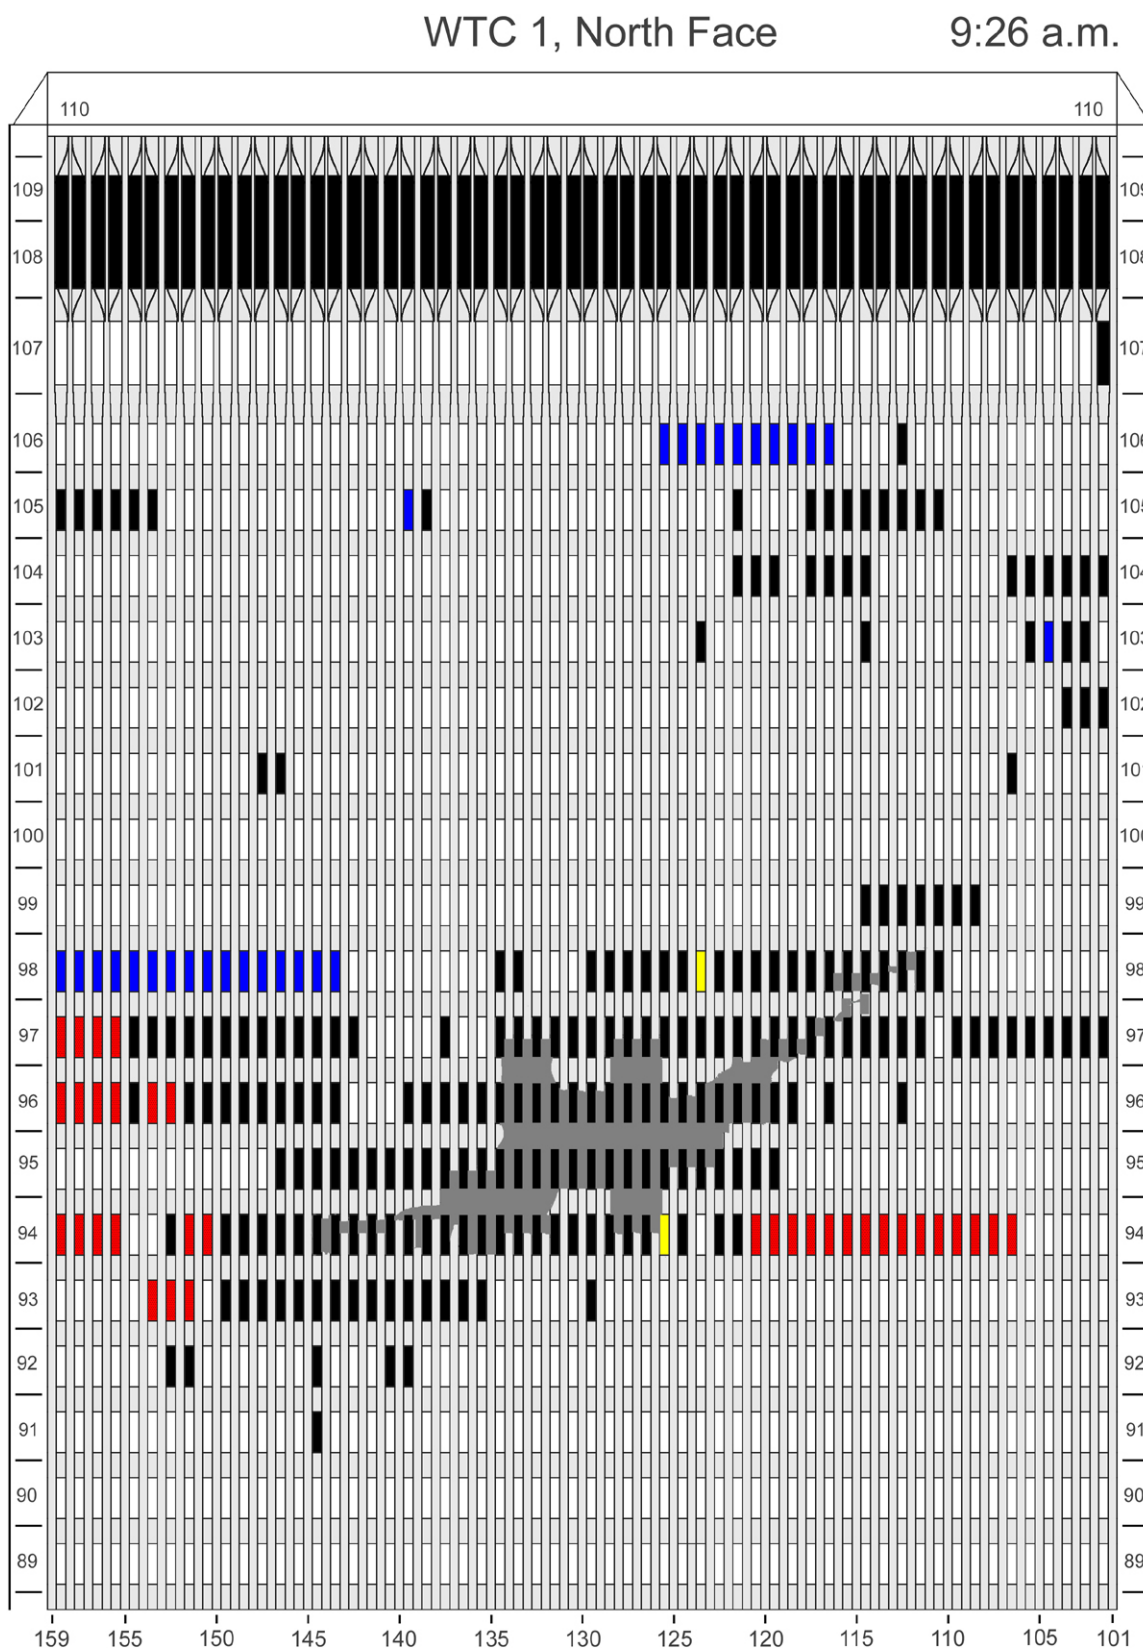
**Figure C-29. Diagram of the north face of WTC 1 for floors 89 to 110 at 9:26 a.m. showing the condition of windows and locations of fires.**

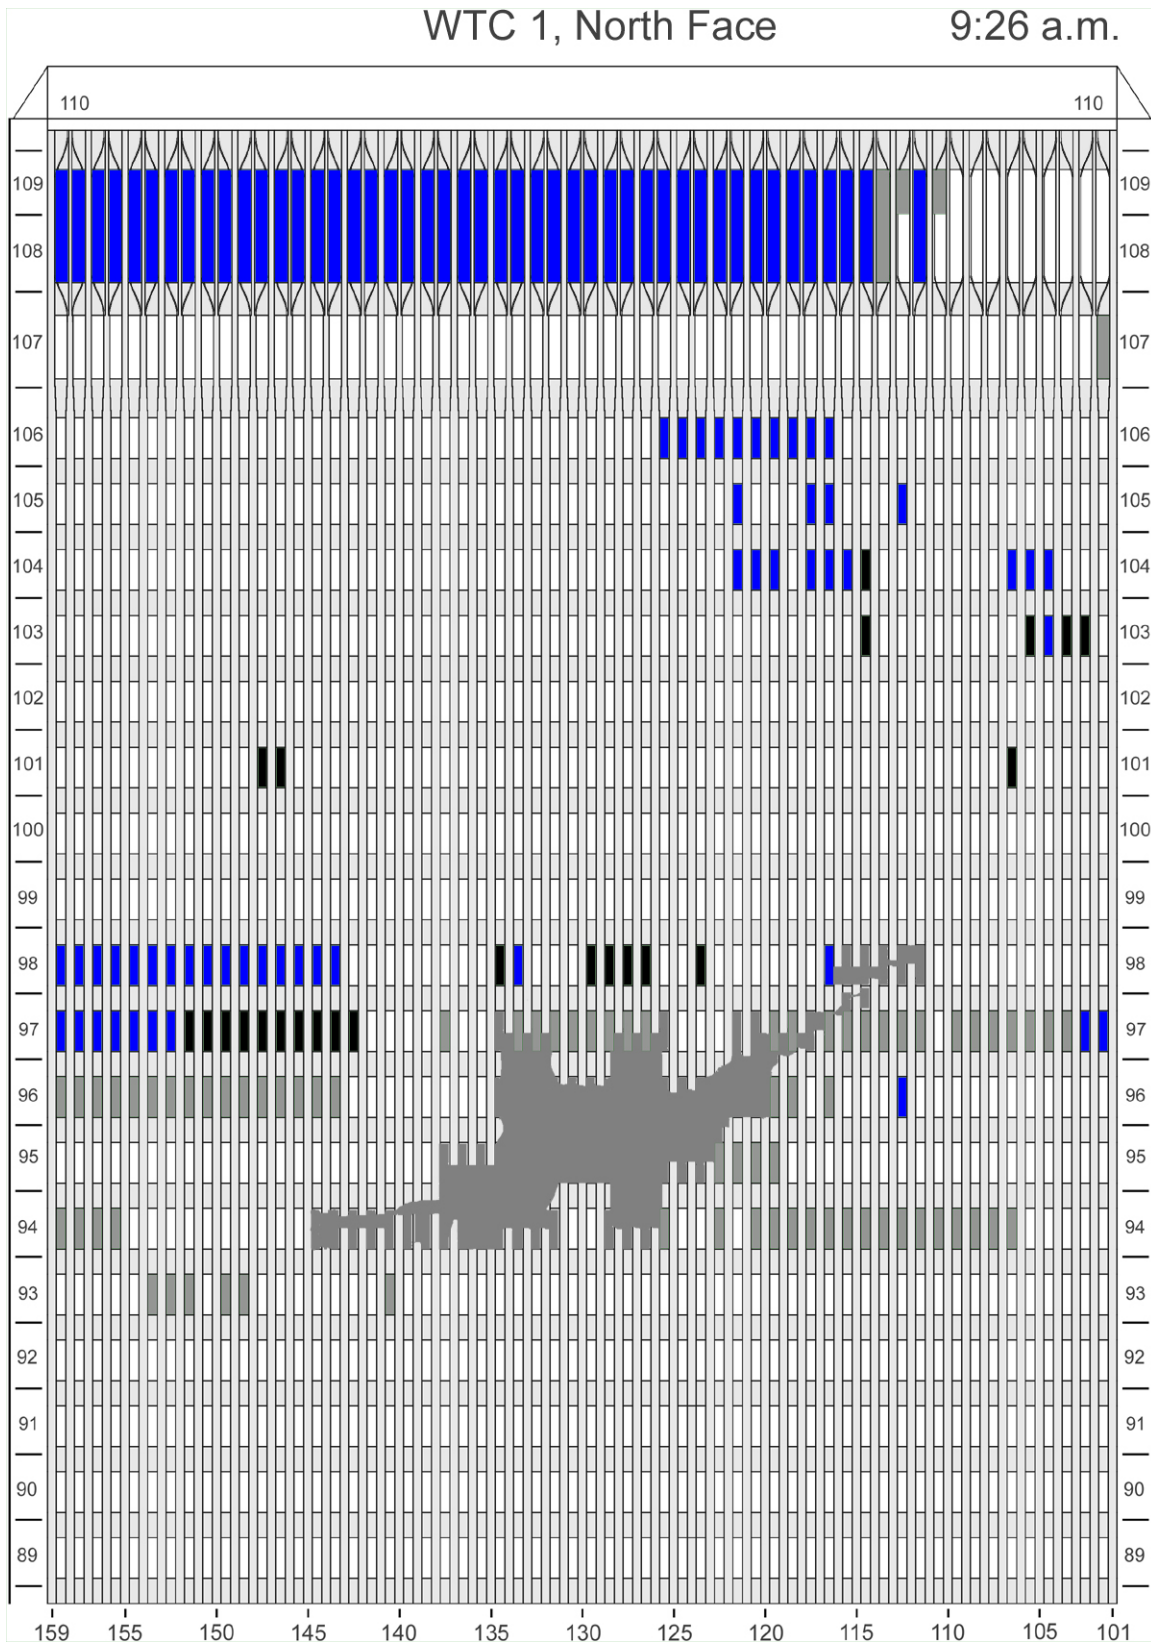
**Figure C-30. Diagram of the north face of WTC 1 for floors 89 to 110 at 9:26 a.m. showing windows where smoke was observed and those that were hidden from view.**
